North Coast Regional Water Quality Control Board

Inspection Report for March 31, 2020 Consent Inspection

Trinity County Assessor's Parcel Numbers 022-330-11, 12, 13, 15, 16, 17, & 18

File: Cannabis Program Inspections, Trinity County, 2019 CDFW Warrant, Levi Carlos Rodriguez, CIWQS Place ID 859663

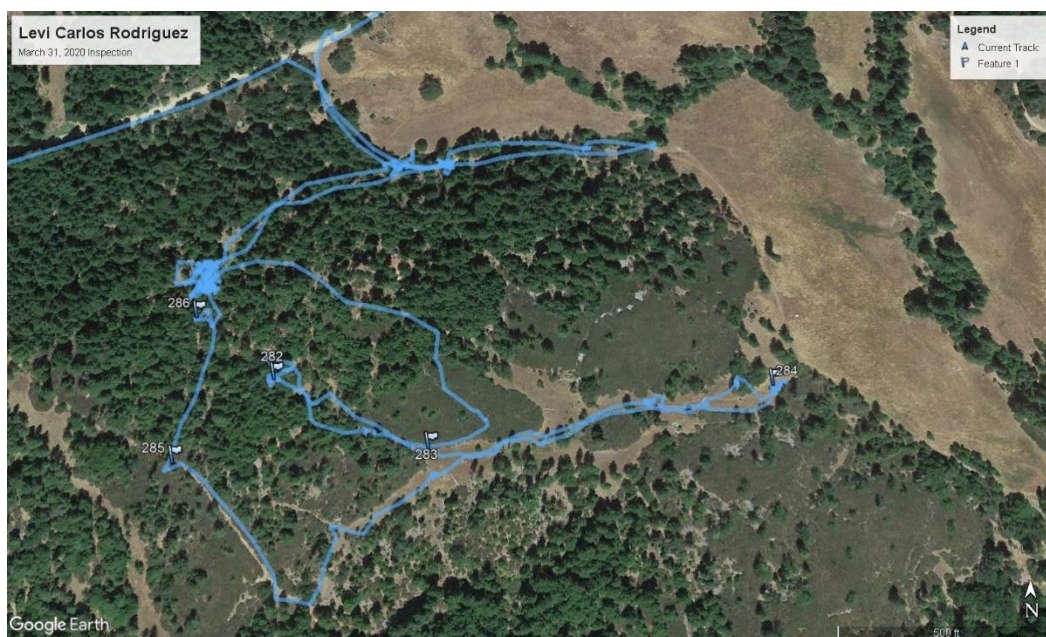
Figure 3. GPS points from March 31, 2020 Inspection, referred to in text below.

- The road currently concentrates water and road runoff toward Pond 2. Pond 2 is full and overflowing toward the wetland, Pond 1, and the Class III watercourse. GPS point 283 is an area vegetated with Juncus. Water runs into the wetland and collects in Pond 1, which overflows down the rock spillway, and out into the wetland, then either continues down the road, where it puddles, or toward the well-formed watercourse channel (GPS Point 284).

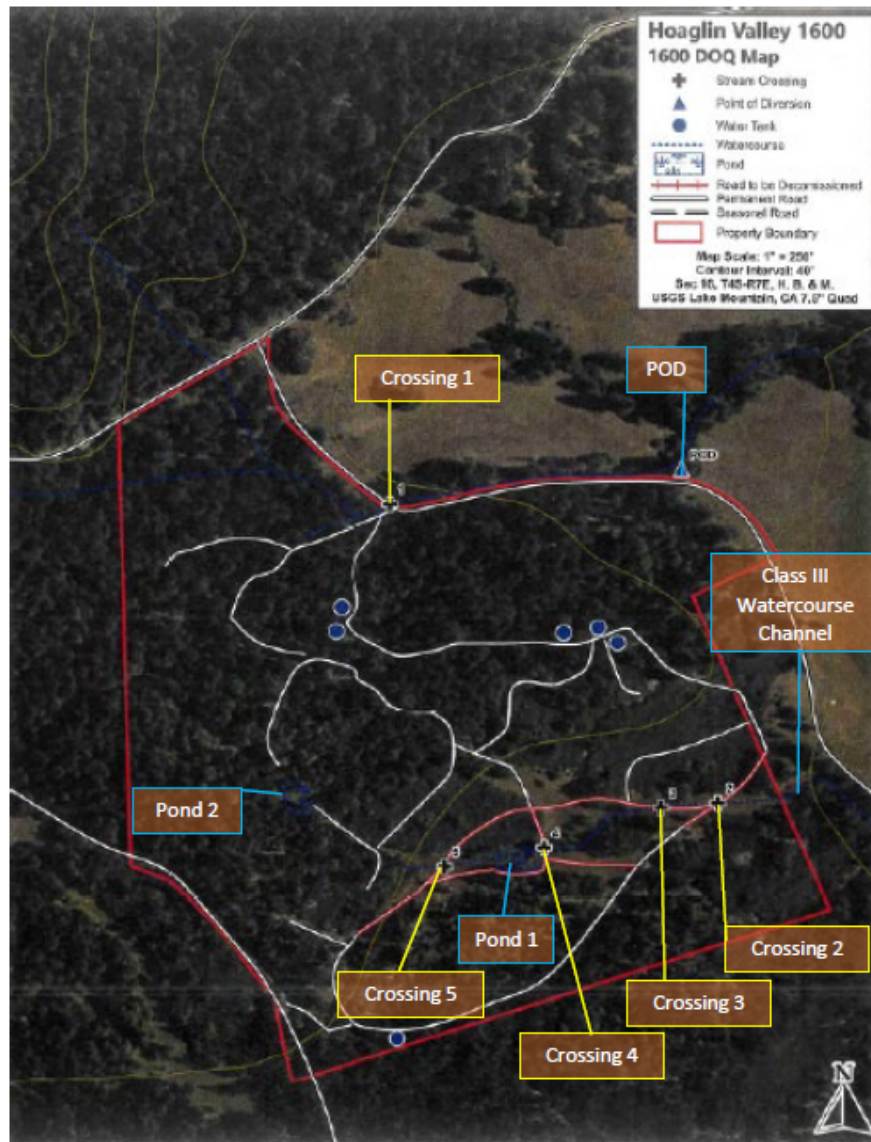
Figure 4. Map submitted with the January 2020 LSAA Notification (TRC) showing outline of Property (all APNs) and modified by me to show more clearly the locations of Features discussed in the following text. My inspection verified that Crossing 1 is on the shared access road on a Class II segment of Hoaglin Creek (WQ2 in my June 2019 Report). Crossing 4 is associated with the onstream Pond 1 and the fill placed in the wetland (WQ1 in my June Inspection Report). Crossing 2 & 3 are associated with an older ranch road that is nearly at-grade and was reopened as part of the recent disturbance. Crossing 5 was constructed to facilitate access across the wetland to south and to a cleared area. The extent of wetland impacts extends from upstream of Crossing 5 to downstream of Crossing 2, just beyond the Property boundary. The Class

III watercourse channel is well defined at the location shown, downstream of Crossing 2.

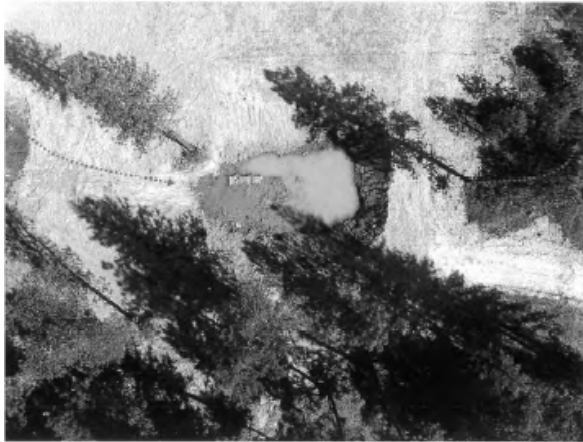
Picture 23: Aerial image of the Pond and the embankment at Crossing #4. Photo date 8-06-2019

Figure 5. The January 2020 LSAA Notification includes this drone photograph of the onstream Pond 1 and Crossing 4 on August 6, 2019, with flow path depicted.

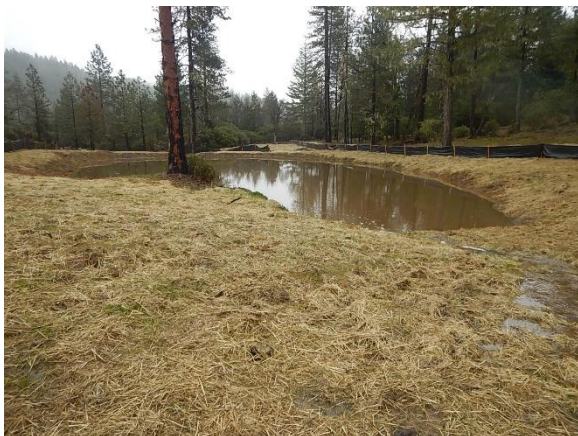
Figure 6. Pond 1 looking from upstream to downstream toward Crossing 4 which is an earthen fill berm.

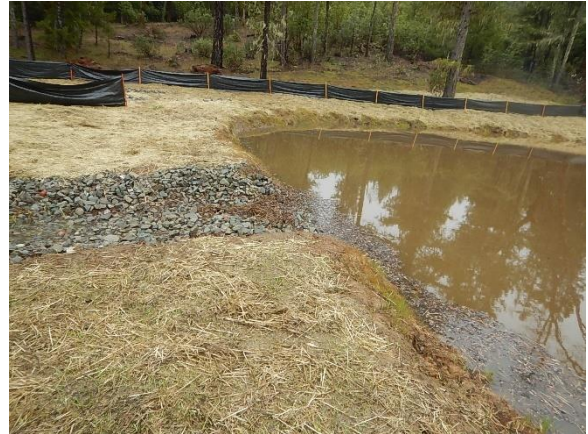
Figure 7. Pond 1 berm with notch and rock applied for a spillway.

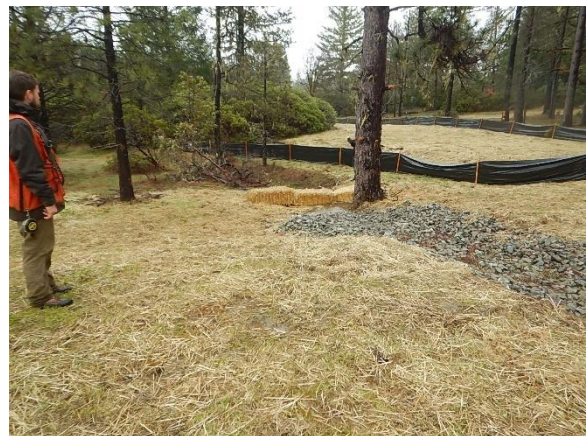
Figure 8. Rock spillway draining to straw bales.

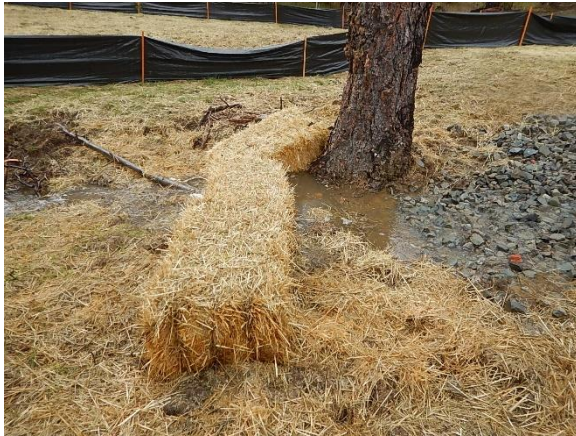
Figure 9. Pond 1 rock spillway draining to straw bales, temporary BMPs.

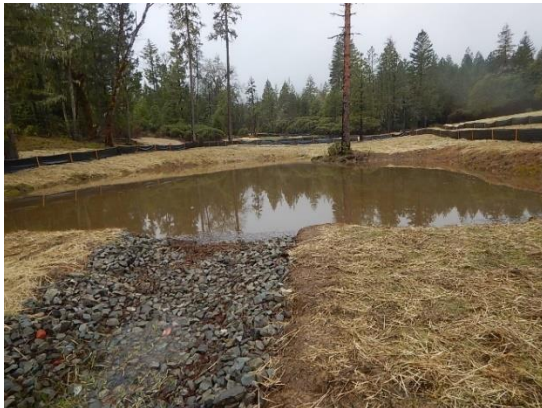
Figure 10. Pond 1, looking upstream with fill in foreground.

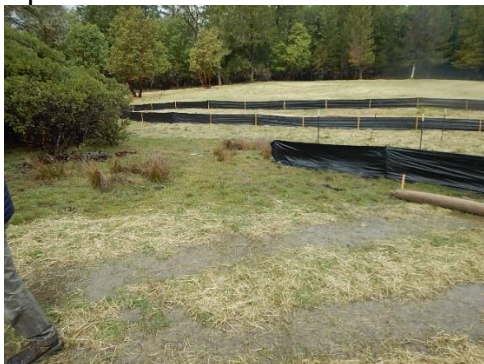
Figure 11. Surface flow is present throughout the area between Pond 2 at GPS points 282 and 284 at the watercourse channel.

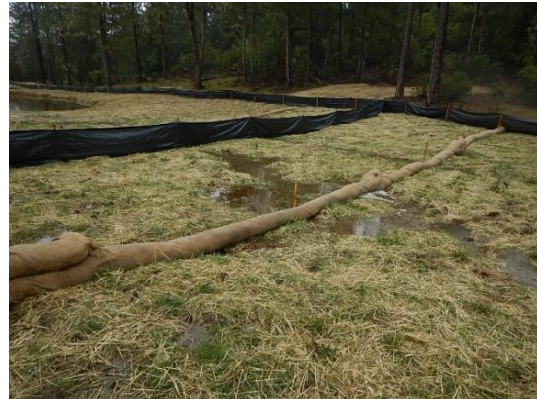
Figure 12. Surface flow upstream of Pond 1.

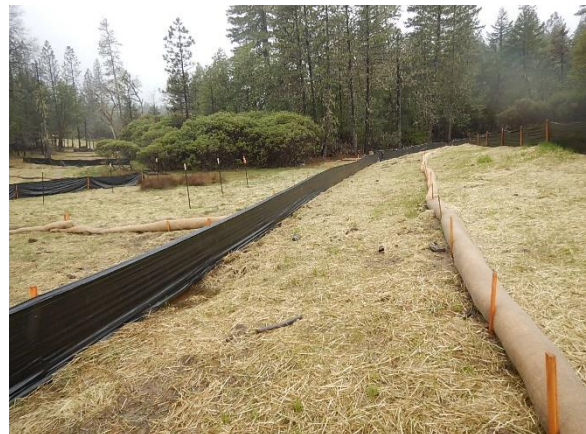
Figure 13. Looking upstream at juncus patch (GPS point 283), Pond 2 is uphill on right.

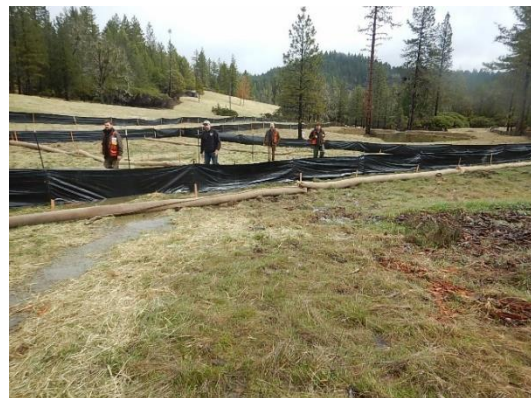
Figure 14. Looking downstream toward Pond 1, note surface flow.

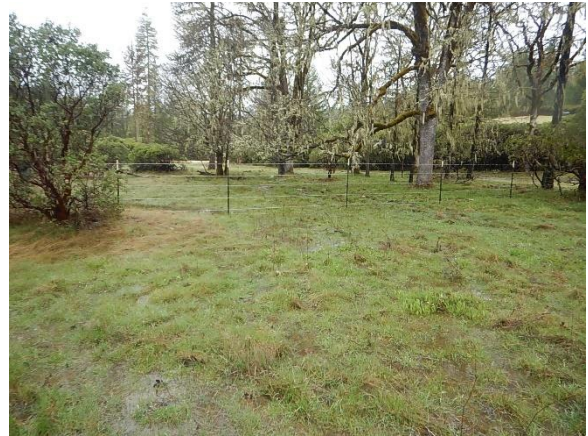
Figure 18. Cattle exclusion fencing downstream of Pond 1.

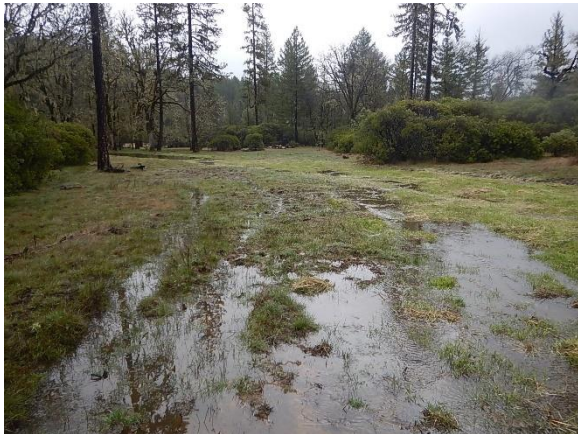
Figure 16. Road downstream of Pond 1 is puddling surface water.

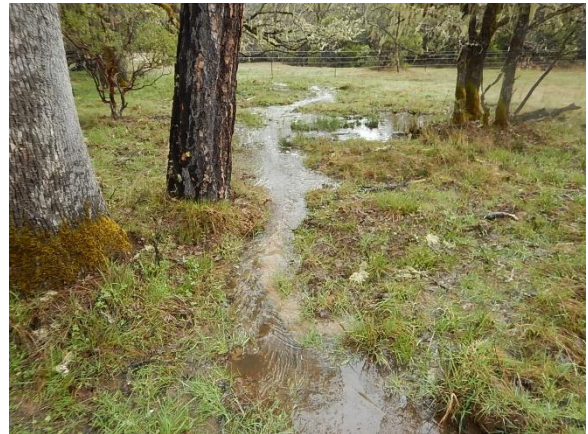
Figure 19. Surface flow downstream of wetland, with cattle exclusion fence.

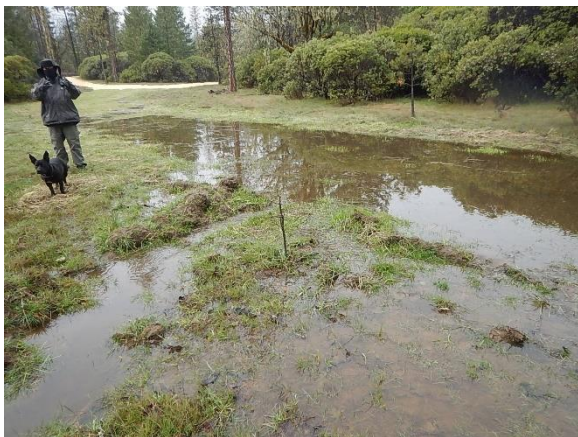
Figure 17. Road downstream of Pond 1 is puddling surface water.

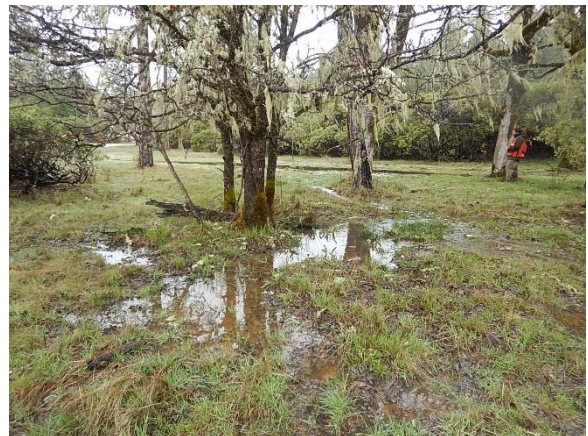
Figure 20. Surface water pools on roadway then joins the watercourse.

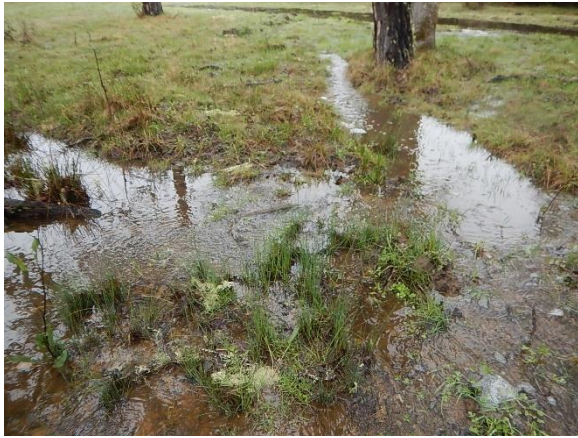
Figure 21. Wetland vegetation upstream of watercourse.

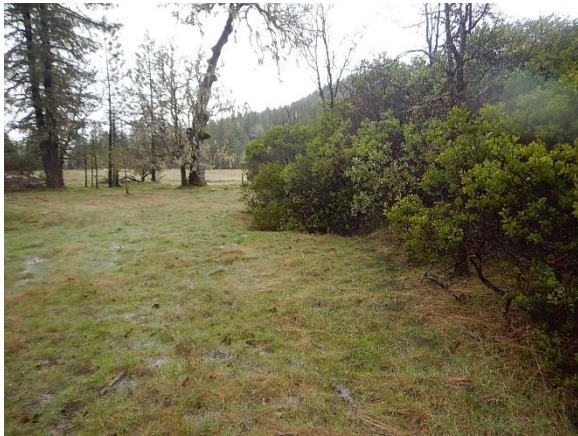
Figure 22. Watercourse channel becomes well defined in manzanita.

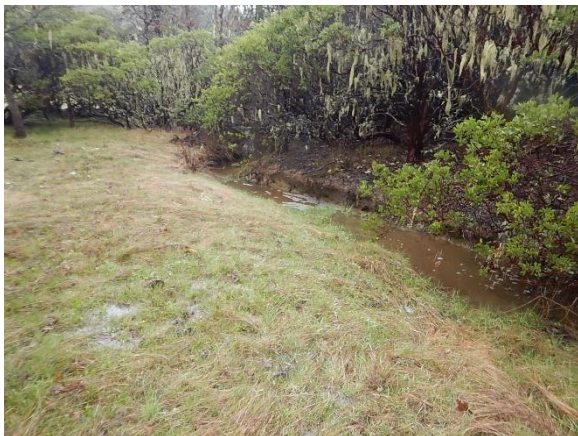
Figure 23. Watercourse channel downstream of wetland.

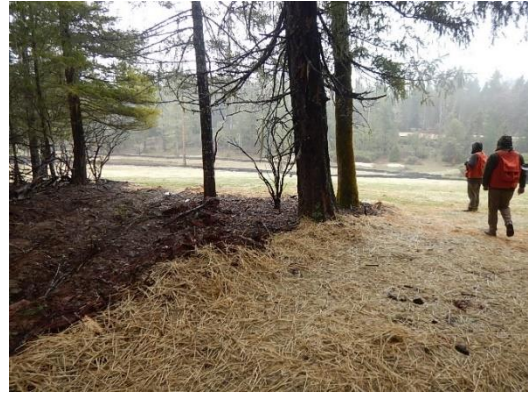
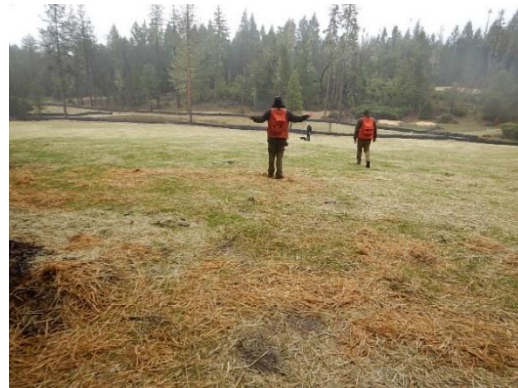
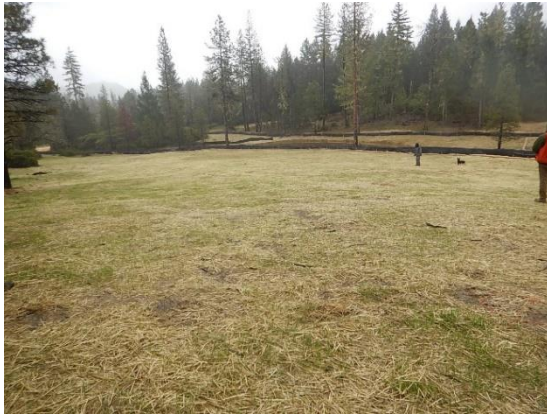
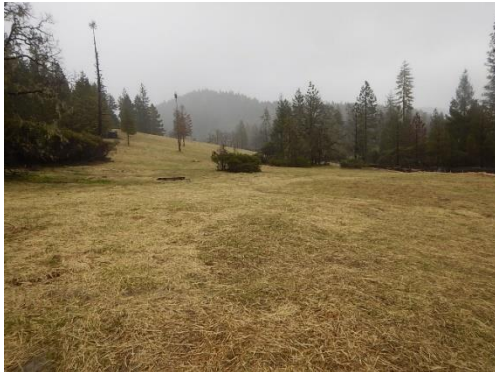
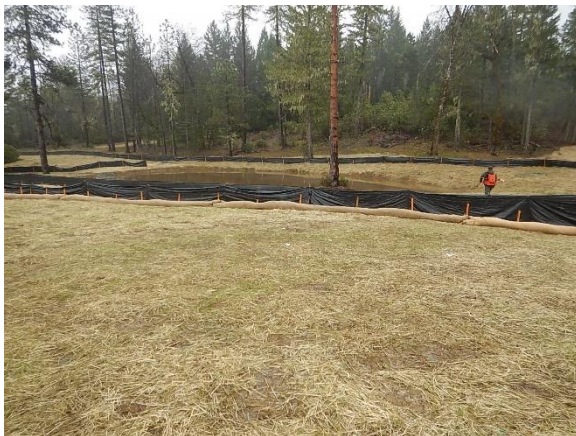
Figure 24. View from slope downstream of Upper Pond 2, looking at graded area surrounding Lower Pond 1.

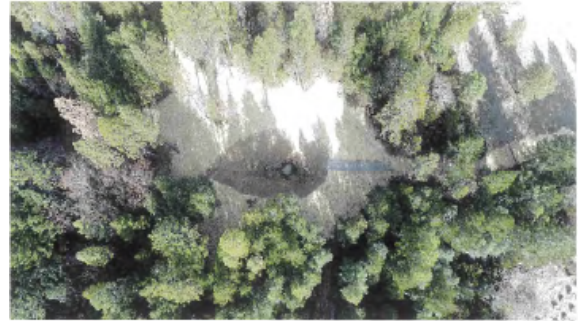
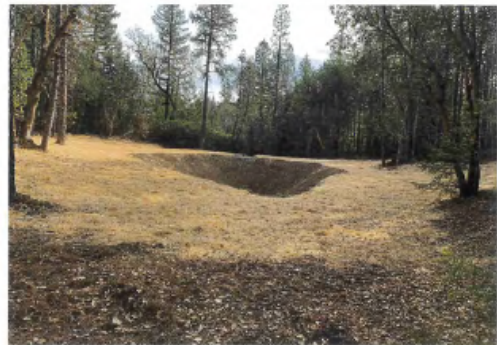
Picture 29 & 30: Aerial image of the Rain Catchment Pond (top) & and looking downslope at the structure (bottom). Photos date 11-13-2019.

Figure 29. The January 2020 LSAA Notification includes this drone photograph of the onstream Pond 2, November 13, 2019.

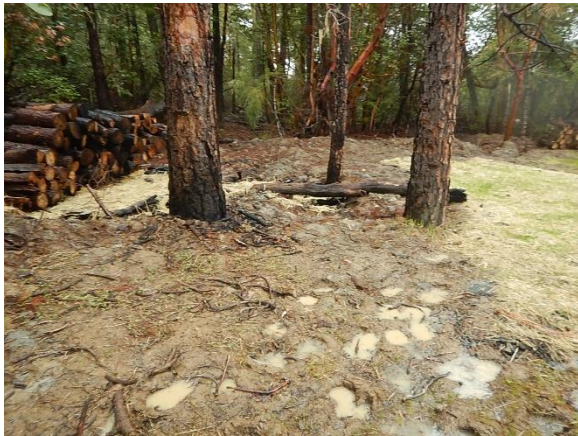
Figure 32. Area adjacent to Pond 2 in need of more erosion control.

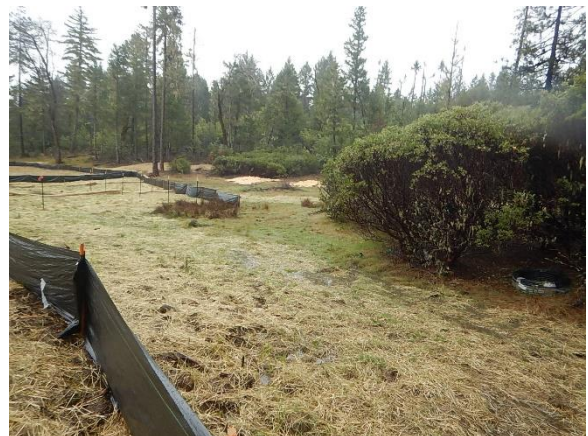
Figure 36. Area downslope of Pond 2, note wetland vegetation at base of slope (GPS point 283).

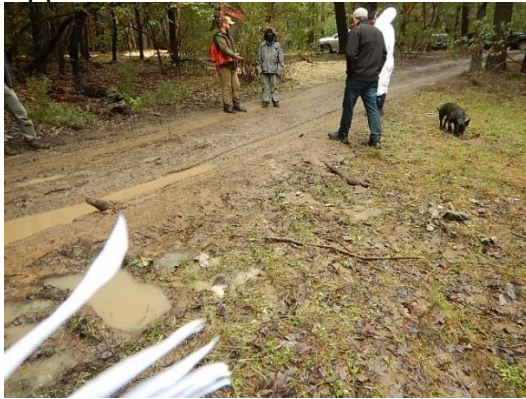
Figure 37. Upslope of Pond 2 is a roadway with a soft surface pooling water and contributing turbid runoff to Pond 2.

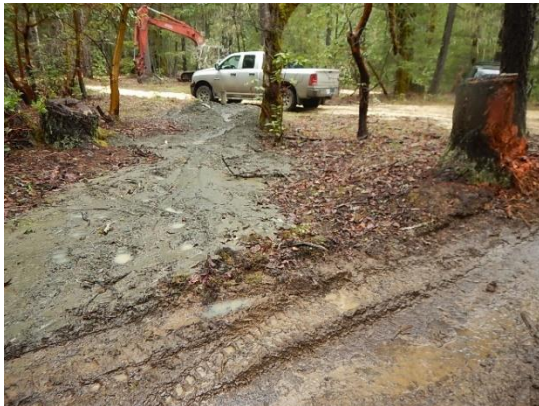
4. Spoils management: Earthen spoils associated with site development had been spread and smoothed over the site and treated with erosion control measures. I observed unstabilized spoils from recent well drilling.

Figure 38. Well drilling spoils.

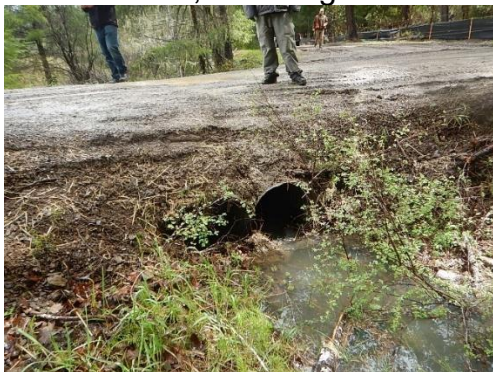
2. Stream crossing maintenance and improvement: Crossing 1 is undersized and needs to be upgraded, as described in the LSAA Notification. Fine sediment from the road surface is susceptible to erosion and delivery into the watercourse; the road surface over the crossing should be rocked or otherwise protected.

Figure 39. Double parallel culverts at Crossing 1, looking downstream at the inlets.

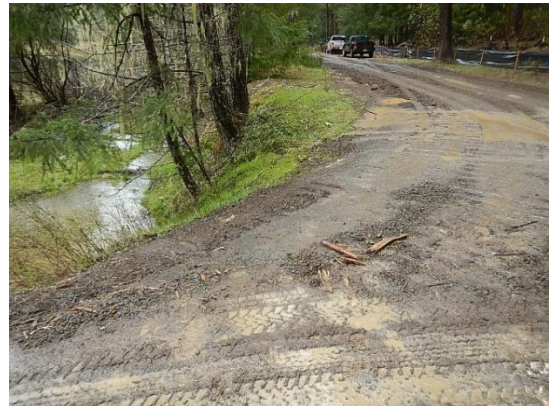
Figure 41. Road surface over Crossing 1 is contributing sediment laden runoff to Class watercourse. Needs rock surfacing.

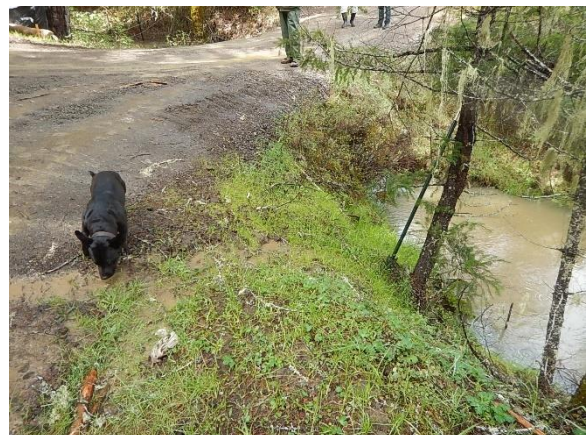
Figure 42. Turbid runoff delivering sediment to watercourse at Crossing 1.

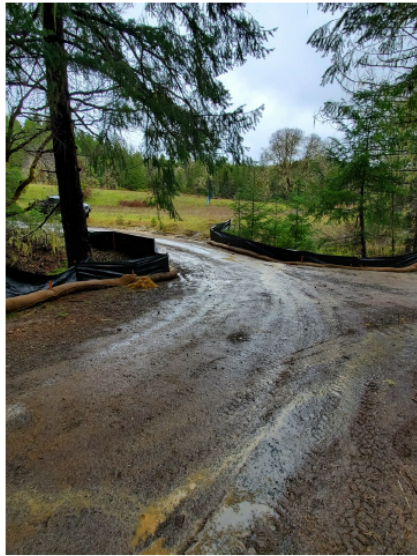
Figure 43. Photo of Crossing 1 submitted by TRC showing installation of silt fences and wattles after our inspection.

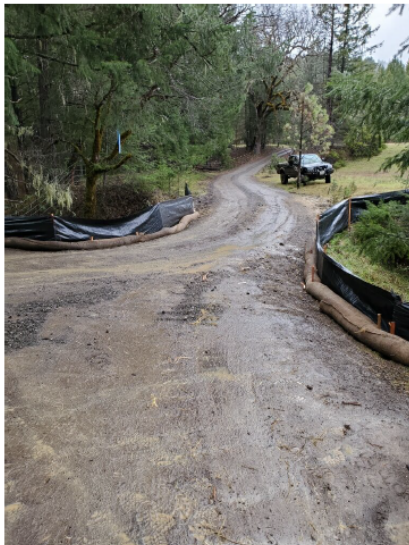
Figure 44. Photo of Crossing 1 submitted by TRC showing installation of silt fences and wattles after our inspection.

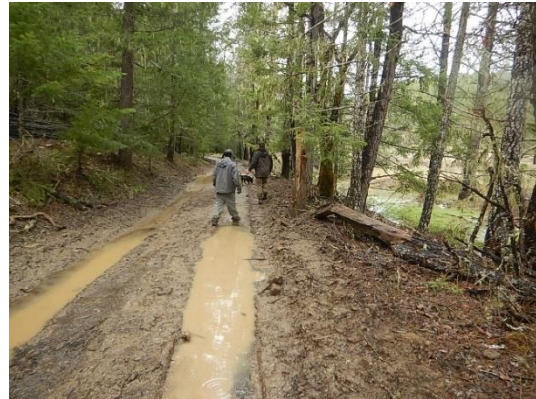
road surface appeared degraded and dusty, indicative of heavy use. As there is no surfacing or armoring, even light winter use is resulting in sediment discharges in violation of the Basin Plan. The road needs rock surfacing and some erosion control to prevent and minimize sediment delivery to the watercourse.

Figure 45. Access road surface is degraded and readily eroding with transport and delivery to Class II watercourse.

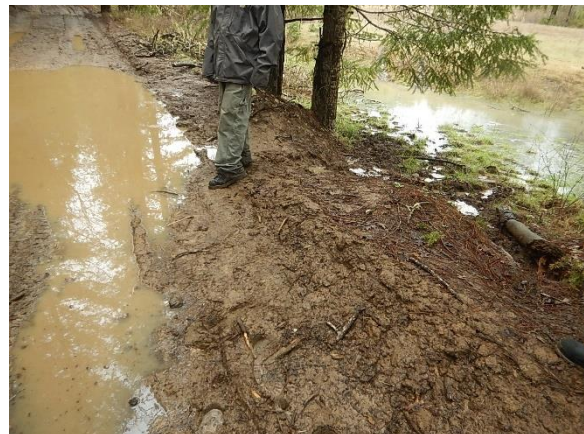
Figure 46. Access road surface is degraded and readily eroding with transport and delivery to Class II watercourse between Crossing 1 and POD.

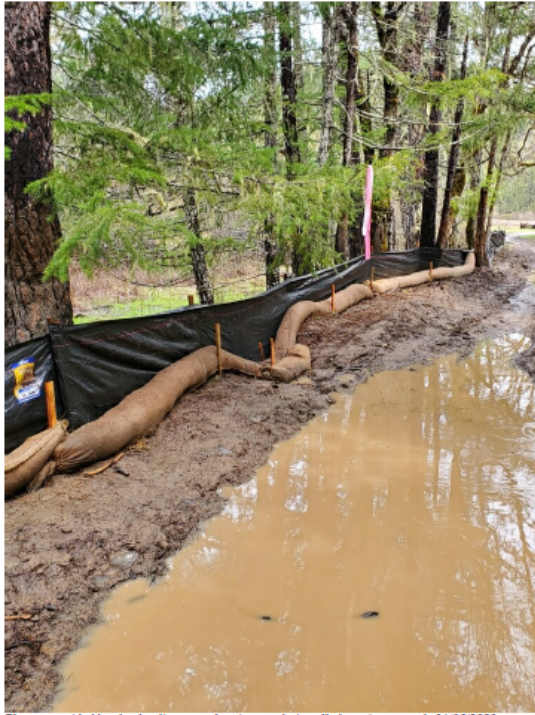
Figure 47. Photo of Access Road submitted by TRC showing installation of silt fence and wattles by dischargers.
